UNITED STATES AIR FORCE
AIRCRAFT ACCIDENT INVESTIGATION
BOARD REPORT

C-130H3, T/N 93-1458

**156TH AIRLIFT SQUADRON
145TH AIRLIFT WING
NORTH CAROLINA AIR NATIONAL GUARD
CHARLOTTE, NORTH CAROLINA**

DATE OF ACCIDENT: 1 JULY 2012

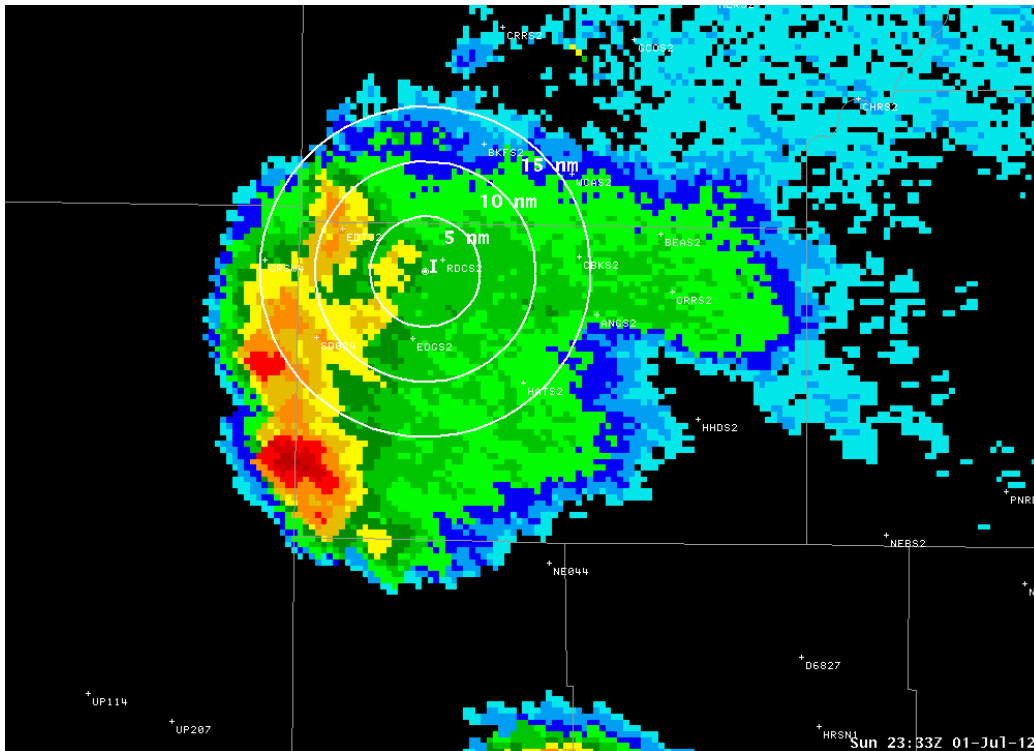
Figure 7. Doppler Radar at 1733L

At 1733L, a moderate rain shower was located approximately 2 miles west of the future mishap site as seen in Figure 7.
