UNITED STATES AIR FORCE
AIRCRAFT ACCIDENT INVESTIGATION
BOARD REPORT

C-130H3, T/N 93-1458

**156TH AIRLIFT SQUADRON
145TH AIRLIFT WING
NORTH CAROLINA AIR NATIONAL GUARD
CHARLOTTE, NORTH CAROLINA**

DATE OF ACCIDENT: 1 JULY 2012

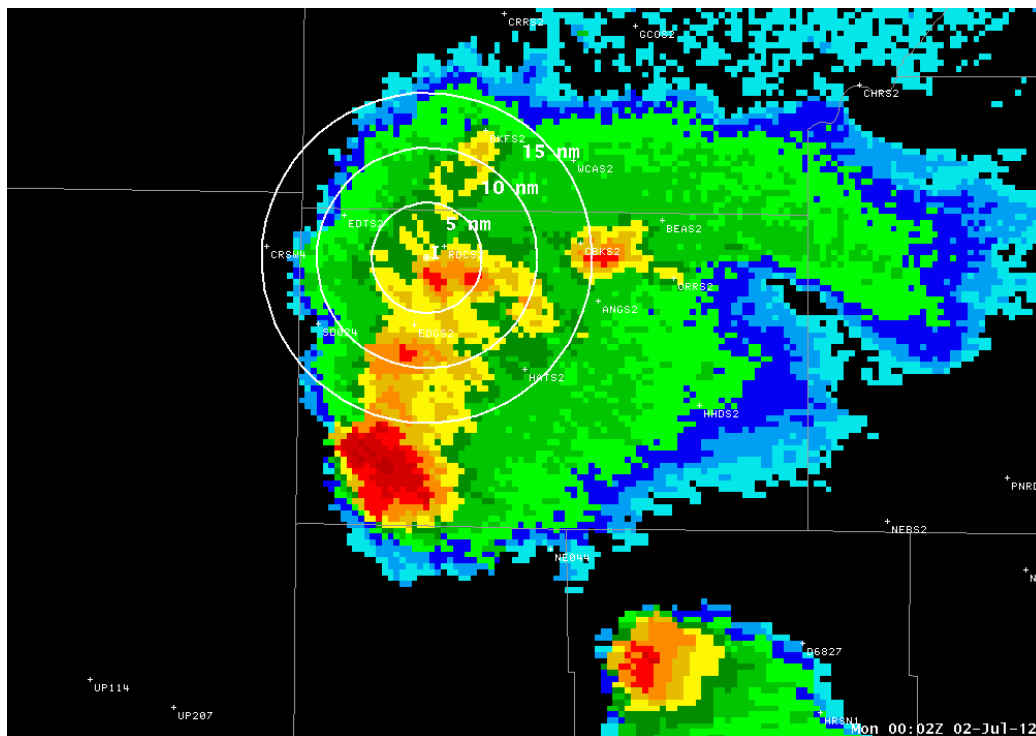
Figure 9. Doppler Radar at 1802L

Shortly after the mishap, a thunderstorm moved over the White Draw Fire area as depicted in Figure 8 above. As Air Attack moved away from the fire area, ATGS witnessed the weather cell on his weather display (Tab R-85). ML1 witnessed a thunderstorm coming and then experienced rain after the mishap (Tab V-1.7). Air Attack and Lead B-5 attempted to get back into the mishap site, but the turbulence was too strong (Tabs R-49, R-136, R-137, V-40.11). Due to the thunderstorm over the White Draw Fire area, as indicated in Figure 9, Air Attack had to loiter approximately 30 minutes for the storm to pass before reaching the mishap site (Tabs R-137, EE-45, EE-46). At approximately 1850L, the first rescue helicopter landed at the mishap site after waiting for the thunderstorm to pass (Tabs R-21, V-1.13, V-3.8 to V-3.9).
